**Schroud Realty Group
LPC# 0316555112
ILN 000 505 540
Cook County
SF/HRS**

CERCLA Site Inspection

Title: CERCLA Site Investigation for Schroud Realty Group

February 8, 2017

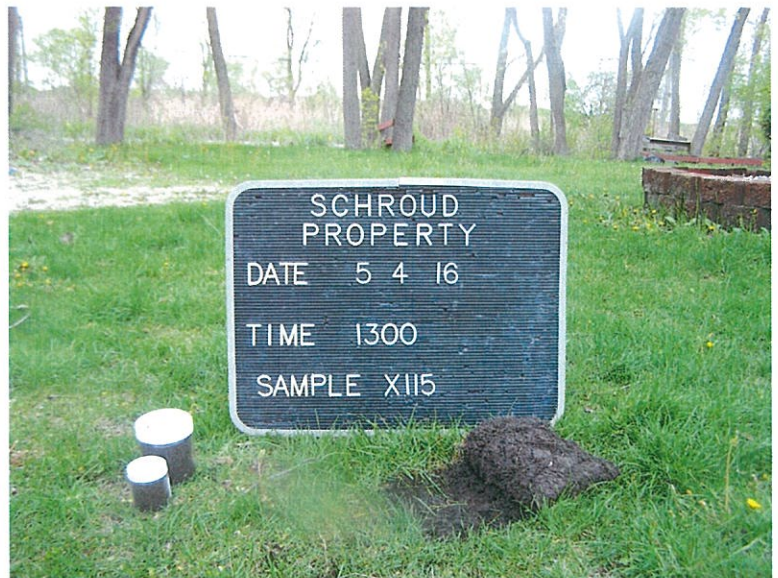
COMMENTS: X115 was collected from a residential property and sampled from the surface for hex chrome and total metals. Soil was black silty loam with some clay and sand.

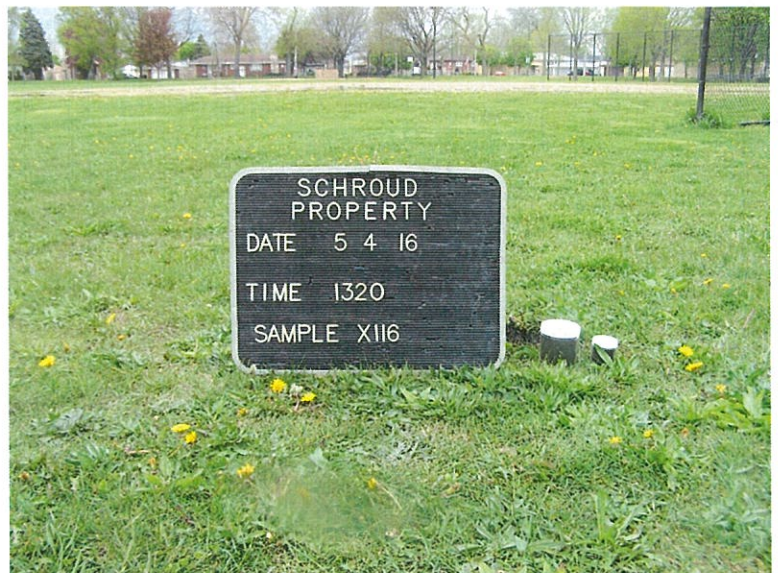
COMMENTS: X116 was collected from near a ball diamond in Mann park and sampled from the surface for hex chrome and total metals. Soil was black silty loam with some clay and sand. This sample was used as a background soil sample.

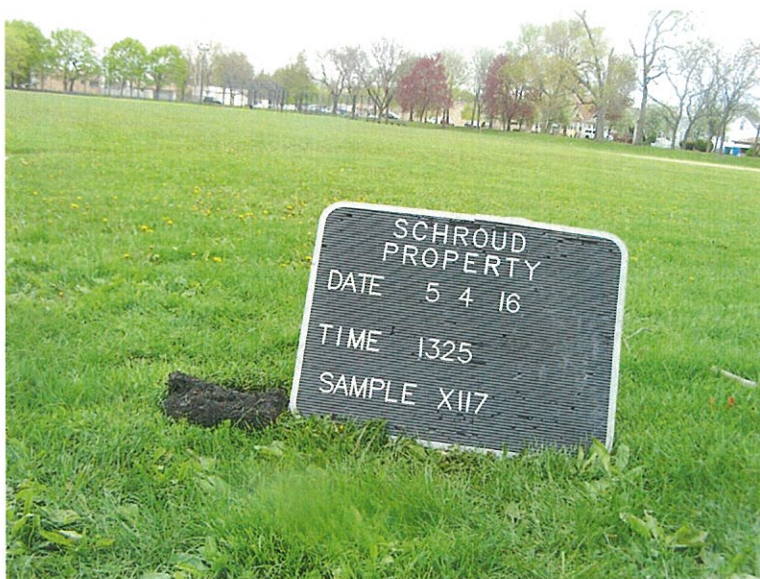
COMMENTS: X117 was collected from near a baseball diamond in Mann Park and sampled from the surface for hex chrome and total metals. Soil was black silty loam with some clay and sand. This sample was used for the soil background.
